# INTERSECTION SAFETY STUDY

Prepared for:  
Ohio Department of Transportation  
District 5 Licking County  
LIC-13 – 9.59  
4<sup>th</sup> Street and W Main Street

Prepared by:  
Toole Design Group and  
Mead & Hunt

March 18, 2019

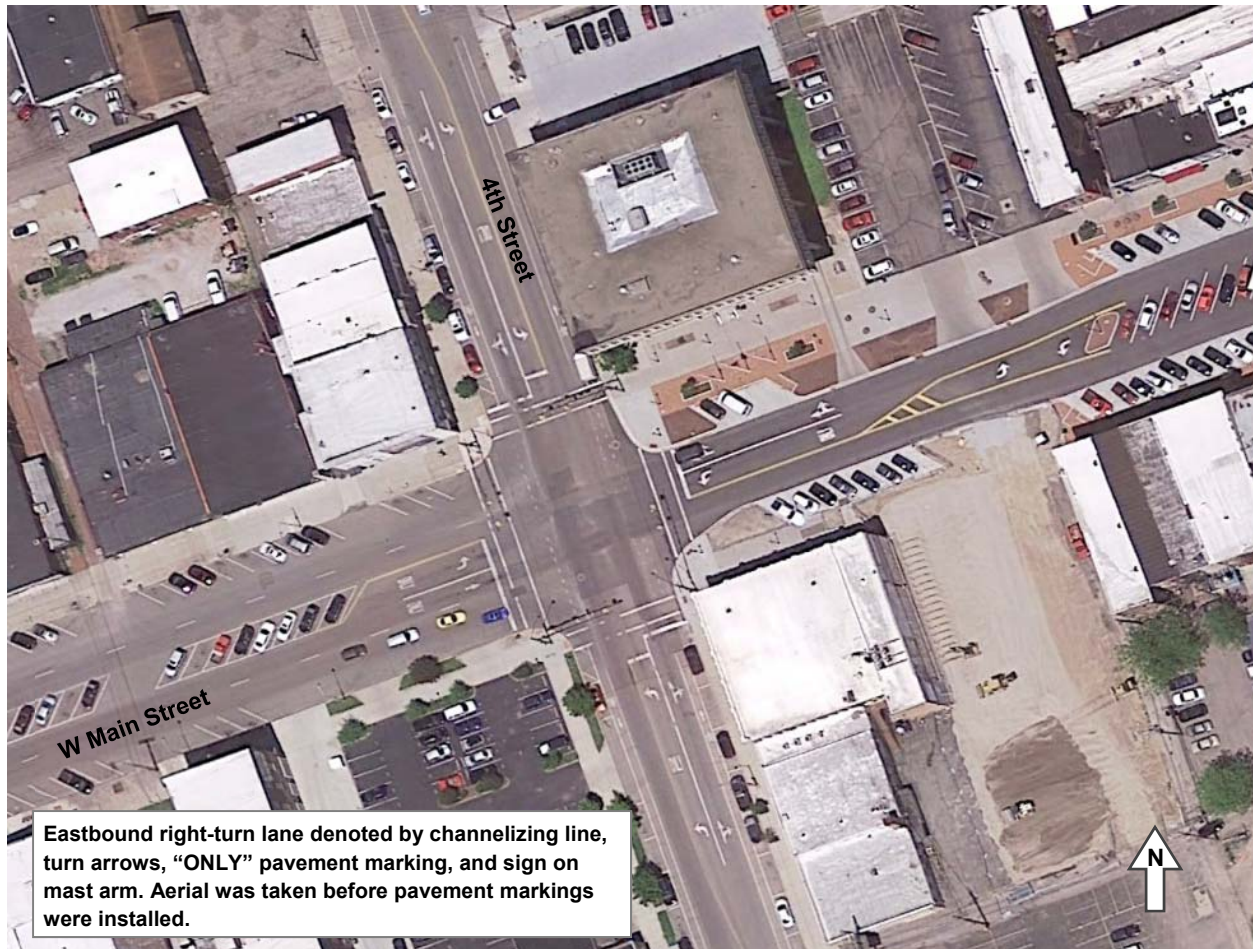
Figure 1: 4th Street and W Main Street

In the northbound and southbound directions at the intersection, 4th Street has a left-turn lane, a shared through / right-turn lane, and one receiving lane. Westbound W Main Street has a left-turn lane, a shared through / right-turn lane and two westbound receiving lanes. Eastbound W Main Street has a right-turn lane, a through lane, and left-turn lane with one eastbound receiving lane. There is angle parking on the curbs and in the median on W Main Street and parallel parking on 4th Street. There are bike lanes on 4th Street that run from W Church Street to W Canal Street. Sidewalks are present on both sides of the street on all approaches to the intersection. The intersection geometry is shown in Figure 1.

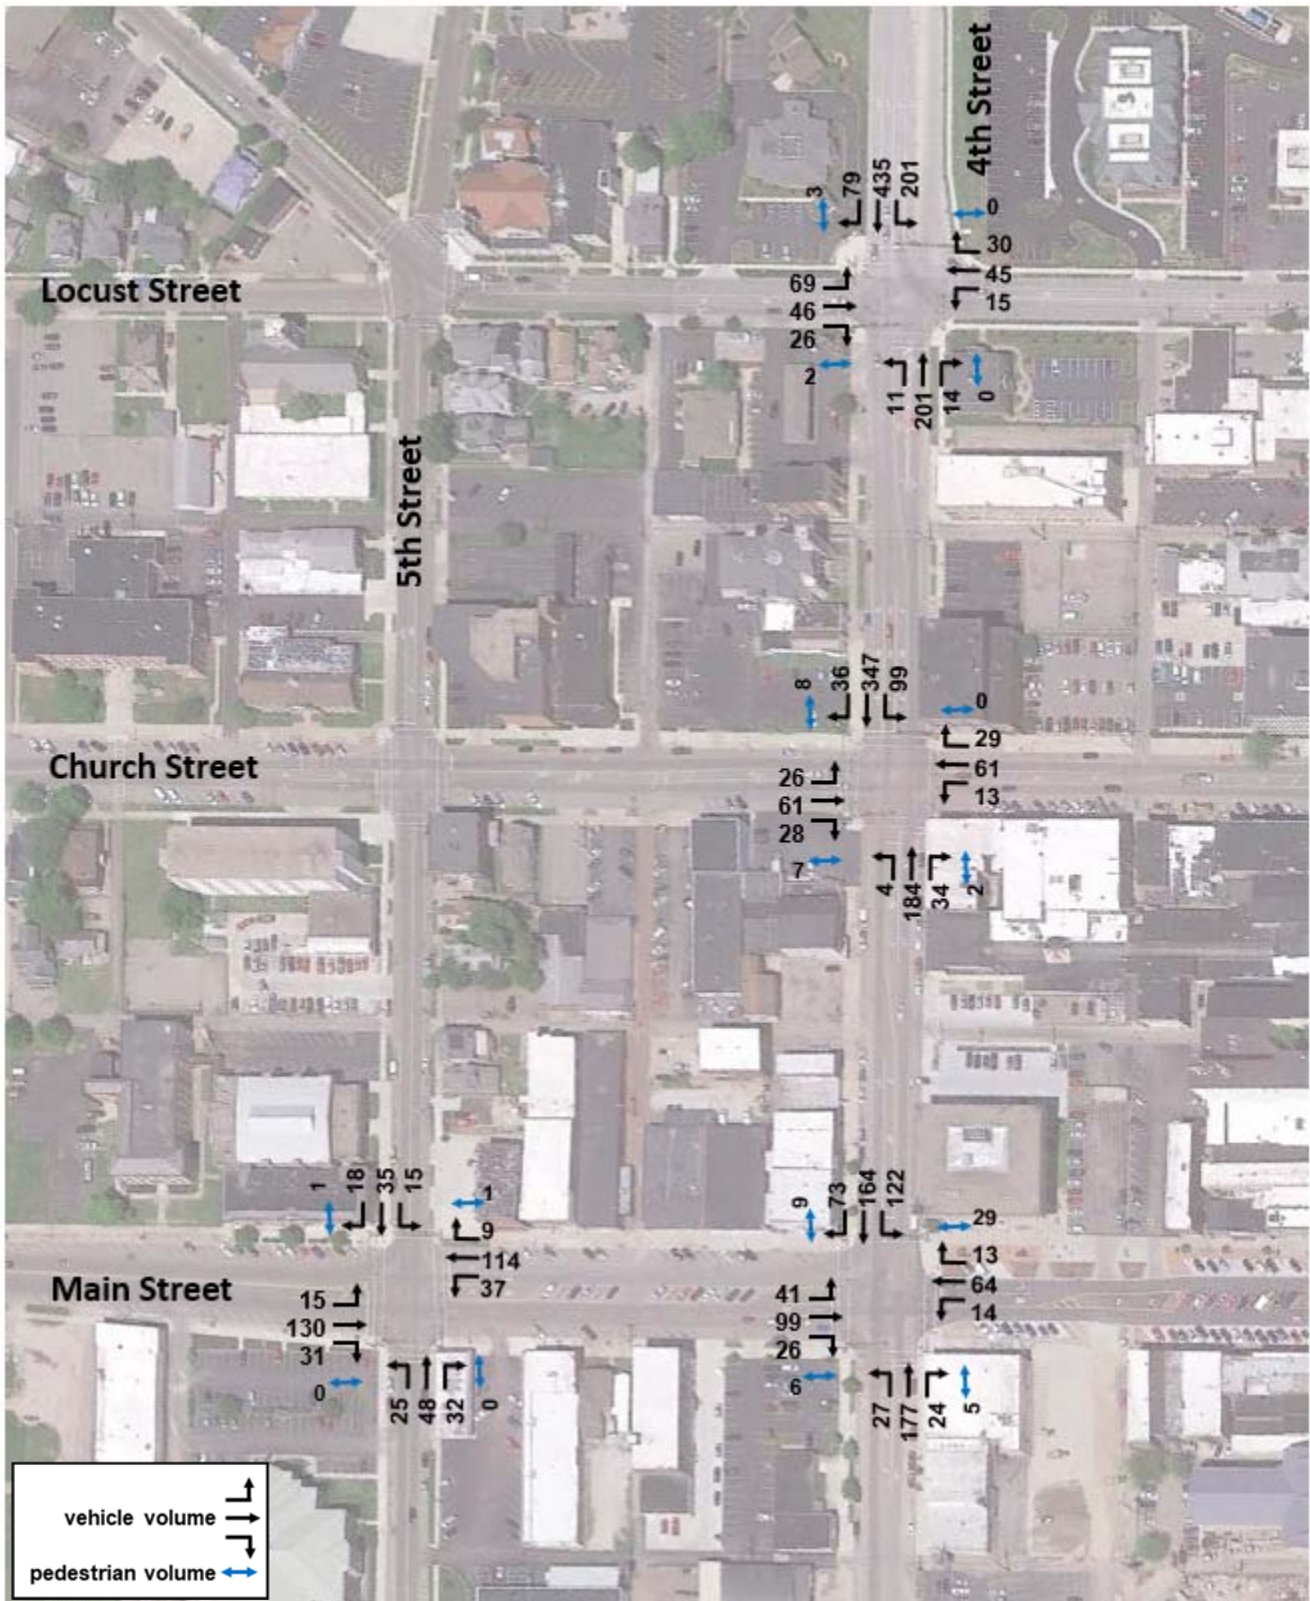
Figure 2: 2018 AM Peak Hour Turning Movement Counts

Turning movement counts were collected on December 4, 2018 for this study. The morning peak hour is from 7:45AM until 8:45AM and the afternoon peak hour is from 3:15PM until 4:15PM. The counts for the AM peak hour are shown in Figure 2 and the counts for the PM peak hour are shown in Figure 3. The 24-hour traffic counts and detailed turning movement counts are given in Appendix A.

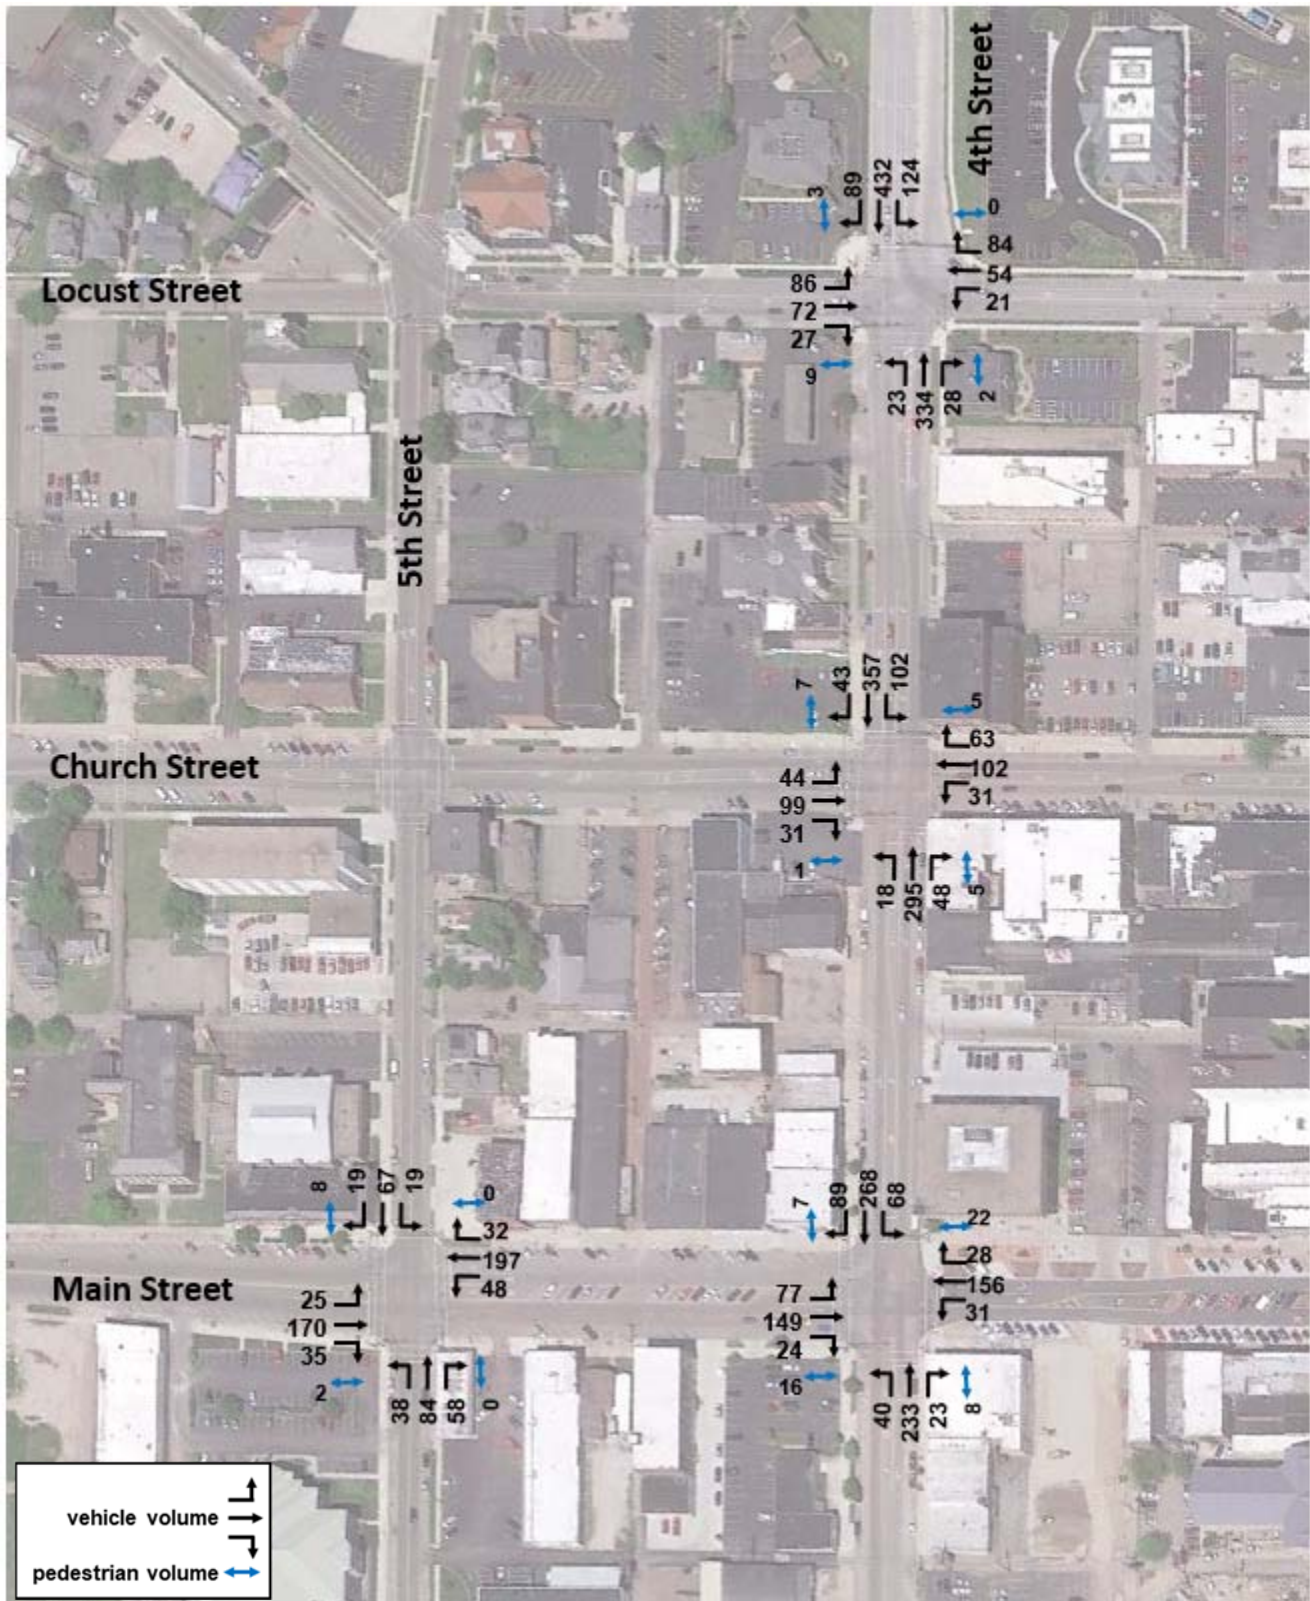
Figure 3: 2018 PM Peak Hour Turning Movement Counts

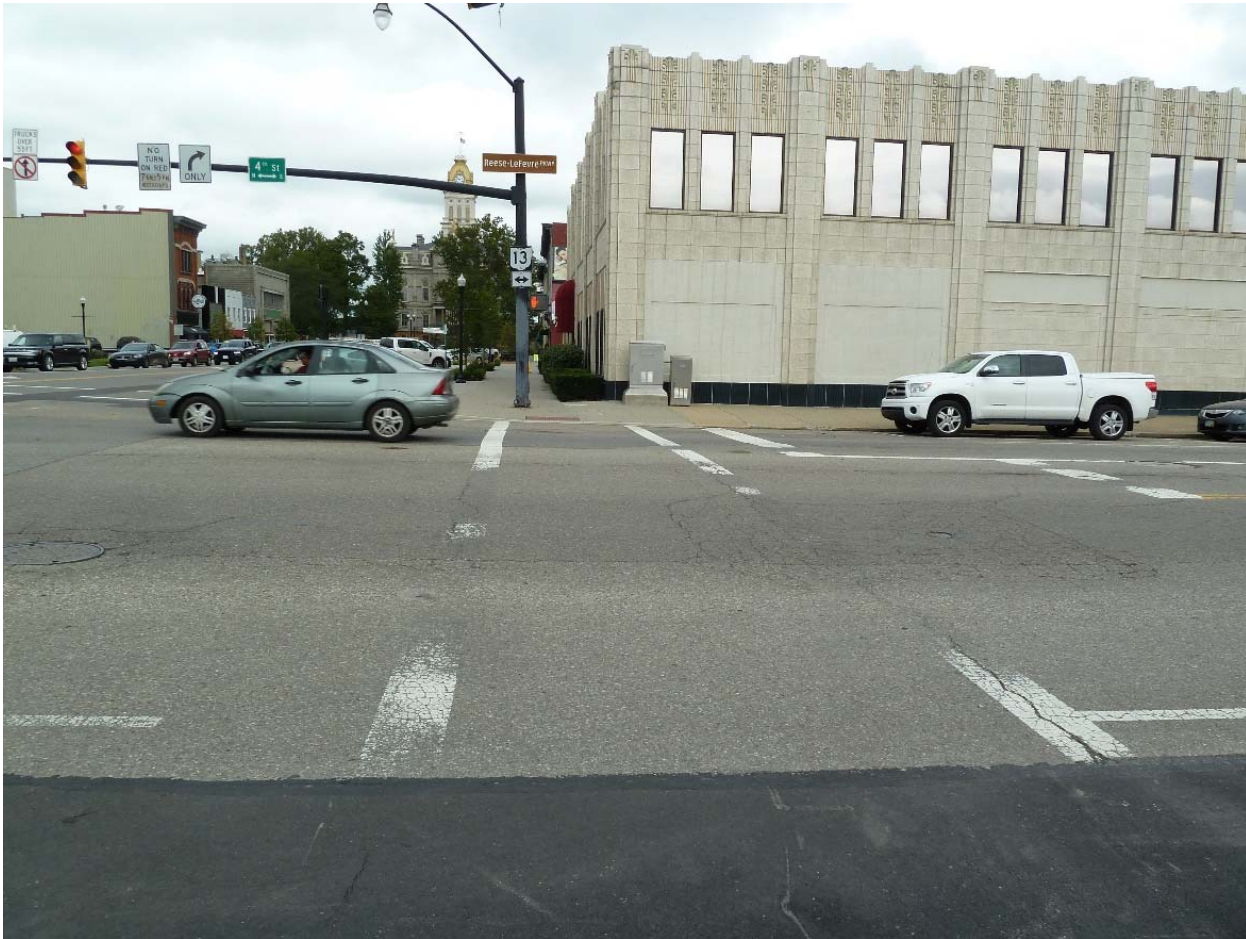
Figure 4: 4th Street pavement condition south of W Main Street

The pavement condition of the approaches to the intersection range from 'Fair to Poor' to 'Very Good' according to the most recent Pavement Condition Rating (PCR) conducted by the ODOT pavement engineering group in 2016. W Main Street was given a PCR of 98, corresponding to a 'Very Good' condition. North of W Main Street, 4th Street was given a PCR of 77, corresponding to a 'Good' condition. South of W Main Street, 4th Street was given a PCR of 58, corresponding to a 'Fair to Poor' condition. Throughout this segment the pavement included occurrences of raveling, patching, crack seal deficiency, rutting, wheel track cracking, block and transverse cracking, longitudinal joint cracking, and thermal cracking. An example of the pavement condition is shown in Figure 4.

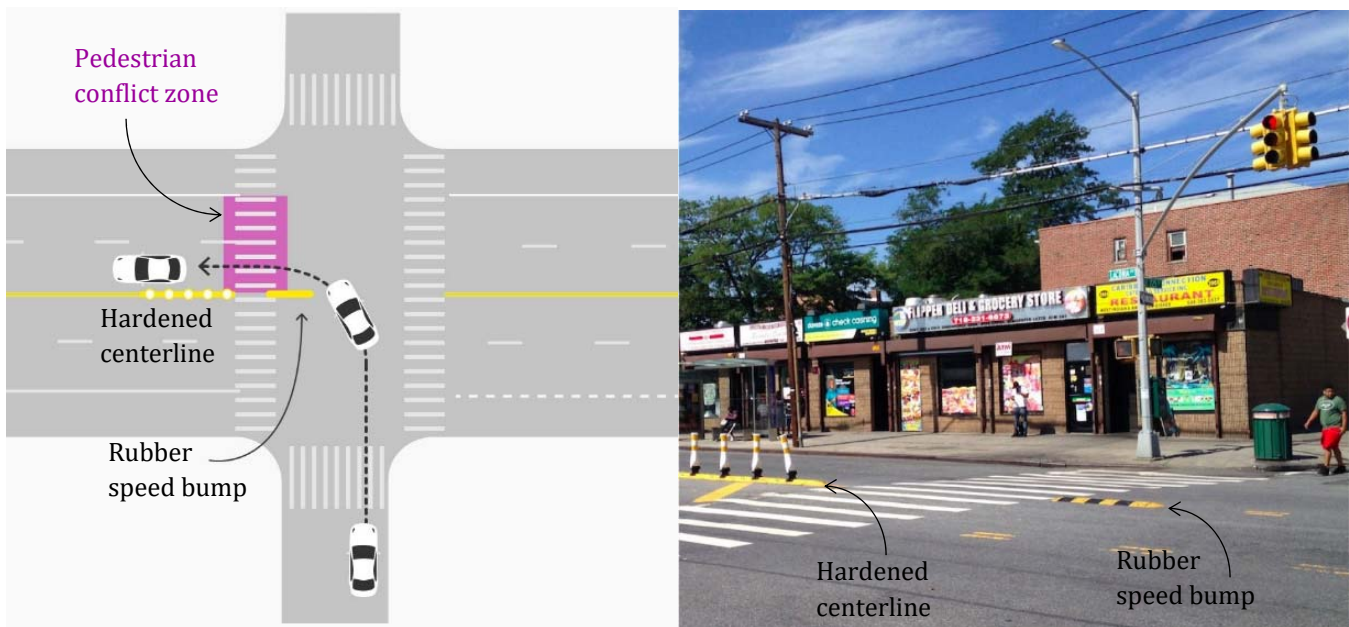
Figure 5: Hardened centerline example (Source: NYC DOT)

1. Reinstall traffic signal in conjunction with the 4<sup>th</sup> Street Sewer Separation project work through the intersection:
  - a. Install a hardened centerline (rubber curb and bollards) on the east and west legs of W Main Street to prevent southbound and northbound left-turning drivers from cutting the corner and to

- decrease the conflict exposure for pedestrians, example shown in Figure 5.
- b. Increase the length of the eastbound left-turn lane at the intersection to accommodate a queue of 100 feet so that drivers turning left do not block the through lane.

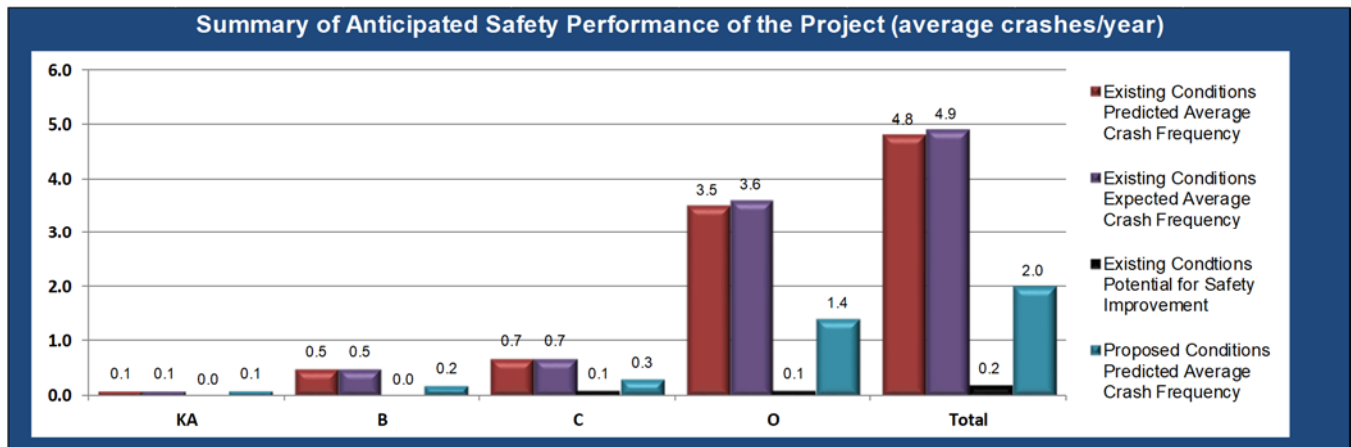
Figure 7: ECAT Existing versus Proposed Conditions Crash Frequency – Roundabout

The countermeasures were analyzed using the Economic Crash Analysis Tool (ECAT) to determine an expected average crash frequency for the proposed conditions, compared to the existing conditions predicted and expected average crash frequencies. The Crash Modification Factor (CMF) Clearinghouse was used to find individual CMFs for each suggested countermeasure. Using the ECAT, each CMF was applied to the relevant approach segment or intersection and the ECAT developed an expected average crash frequency for the roundabout scenario, shown in Figure 7, and the signalized intersection scenario, shown in Figure 8. The ECAT results indicate an expected average crash frequency of 2.0 total crashes per year with the roundabout and 4.2 crashes per year with the signalized intersection, compared to 4.9 total expected crashes per year for the existing conditions. The detailed output from the ECAT can be seen in Appendix D.

The proposed countermeasures in the roundabout scenario are expected to reduce the total number of crashes by 2.9 crashes per year. The proposed countermeasures in the signalized intersection scenario are expected to reduce the total number of crashes by 0.7 crashes per year. Over the course of twenty years, the net present value of the safety benefits of the roundabout scenario is expected to be \$951,000 for a benefit cost ratio of 0.70. The net present value of the safety benefits of the signalized intersection scenario is expected to be \$354,000 for a benefit cost ratio of 0.26.

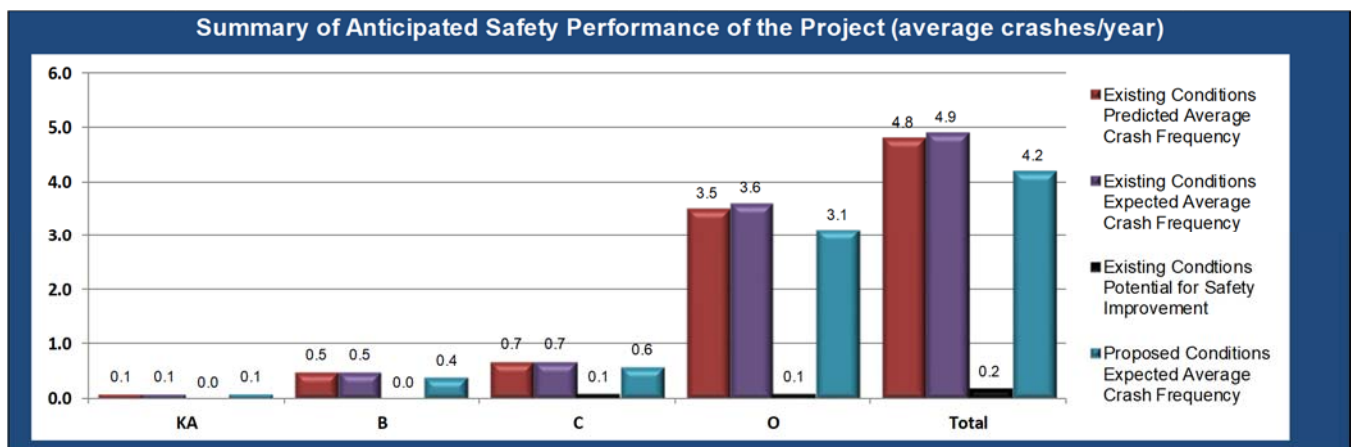
Figure 8: ECAT Existing versus Proposed Conditions Crash Frequency – Signalized Intersection
